**SITE ASSESSMENT REPORT  
FOR  
THE TOLEDO PLATE AND GLASS SITE  
TOLEDO, LUCAS COUNTY, OHIO  
TDD: T05-9204-016  
PAN: EOH0959SAA  
TAT-05-23-02024**

May 7, 1992

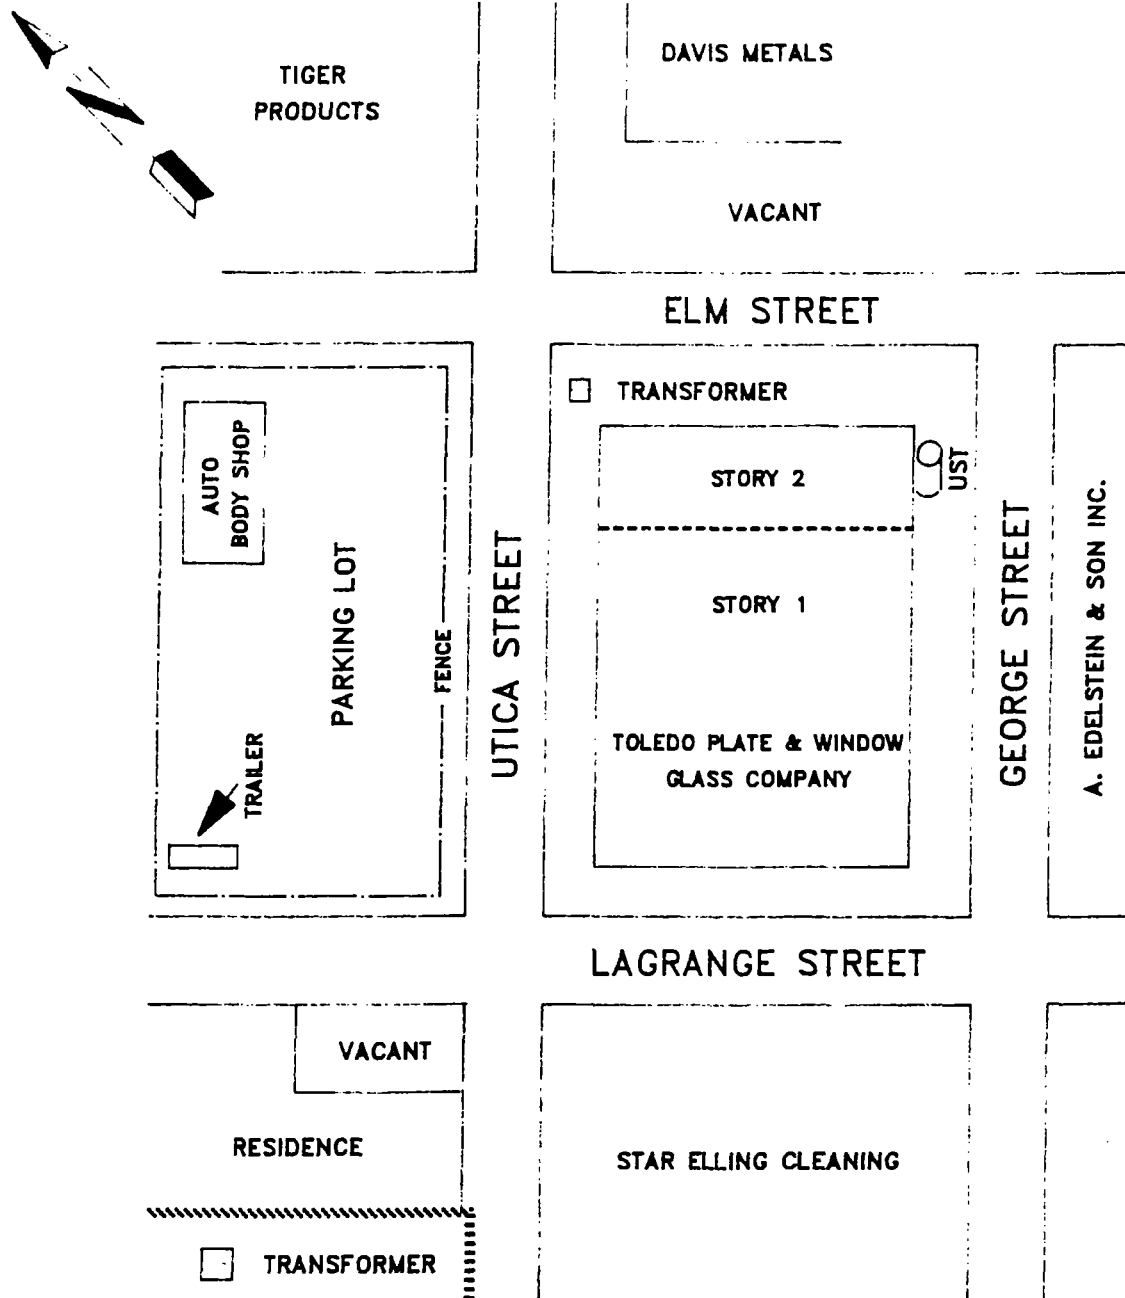
FIGURE 2  
SITE SKETCH  
TOLEDO PLATE & GLASS SITE  
TOLEDO, LUCAS COUNTY, OHIO  
NOT DRAWN TO SCALE

During the initial walk-through, the TAT and OSC Renninger surveyed the general site conditions, noting the locations and conditions of drums and containers, their labels and markings, and marked several containers for pH field screening and/or sampling for laboratory analysis. The main floor was littered with broken glass, cardboard, et cetera, including potentially asbestos-containing pipe insulation.

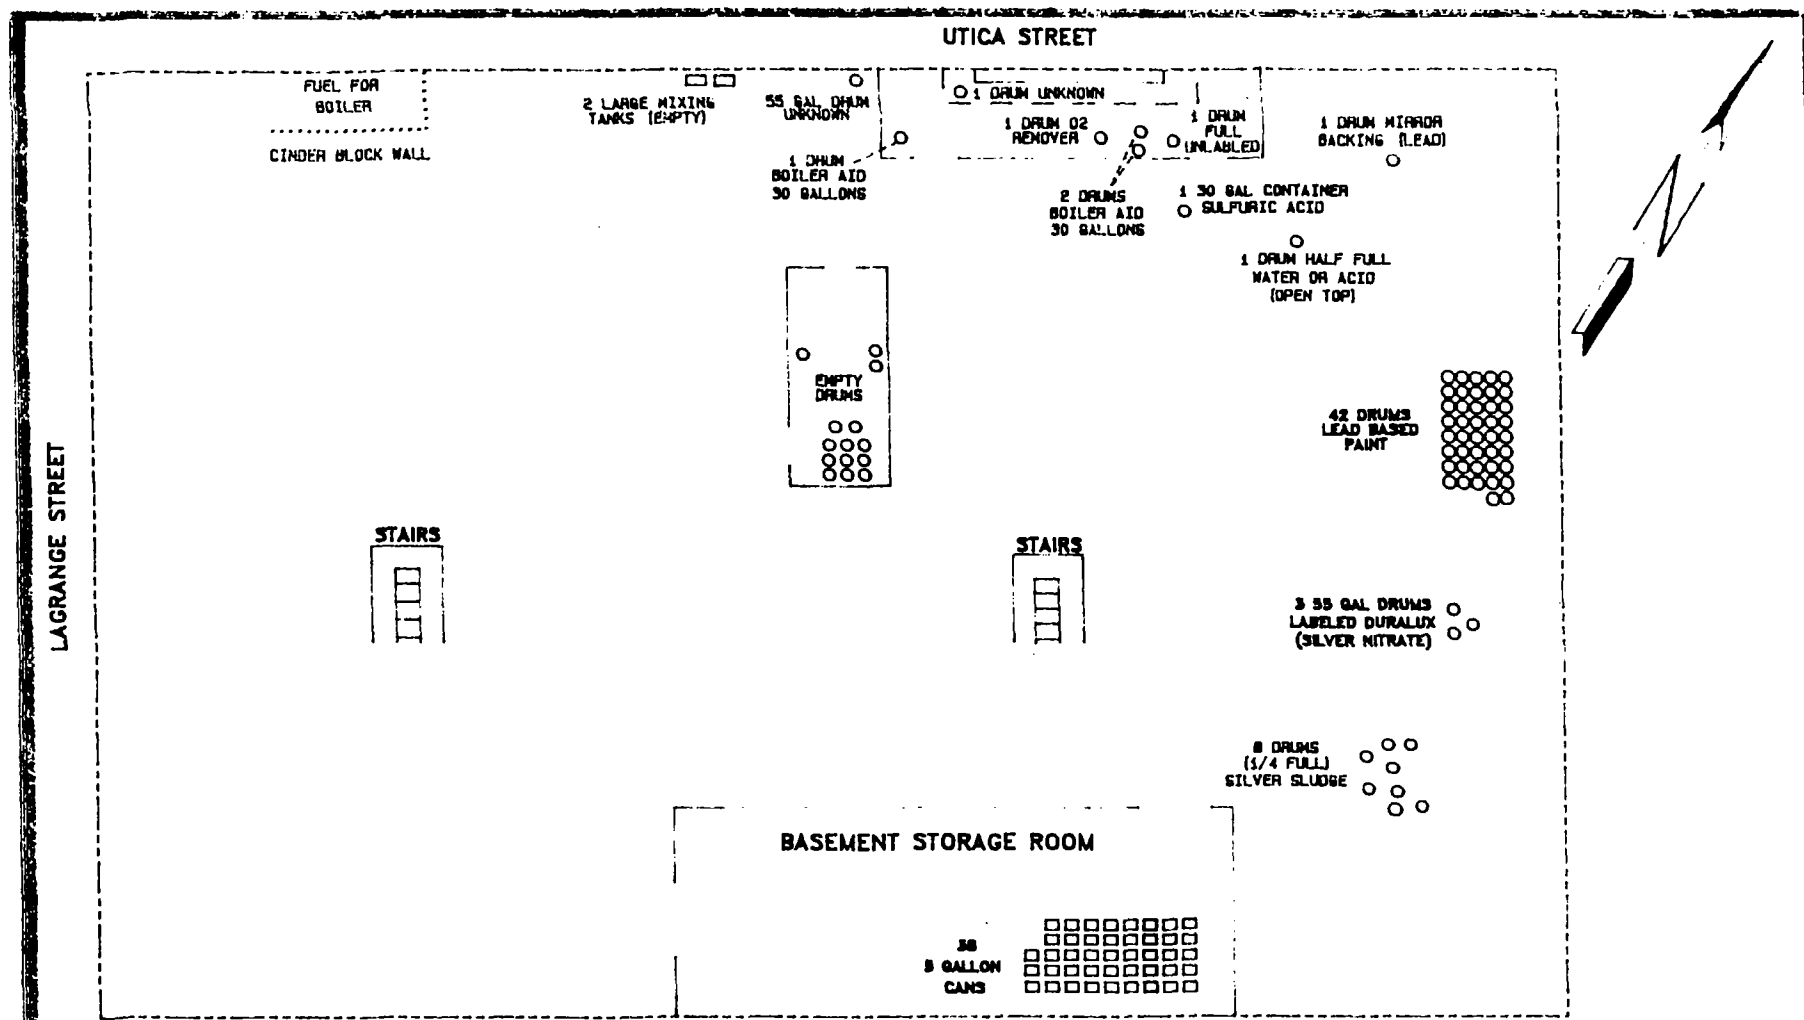
FIGURE 4  
BASEMENT SKETCH  
TOLEDO PLATE & GLASS SITE  
TOLEDO, LUCAS COUNTY, OHIO  
NOT DRAWN TO SCALE

The entire basement was flooded with approximately 12 inches of water; because the electrical power was shut off, the sump pump was not operating. Most of the drums and containers were

The basement of the TPG site was flooded with approximately 12 inches of water. Partially full drums and containers of hazardous materials were floating on top of the water. Many of these drums and containers were in poor condition, potentially allowing hazardous substances to escape. Drums and containers in the water are especially susceptible to rusting, promoting drum failure, and causing a hazardous materials release.

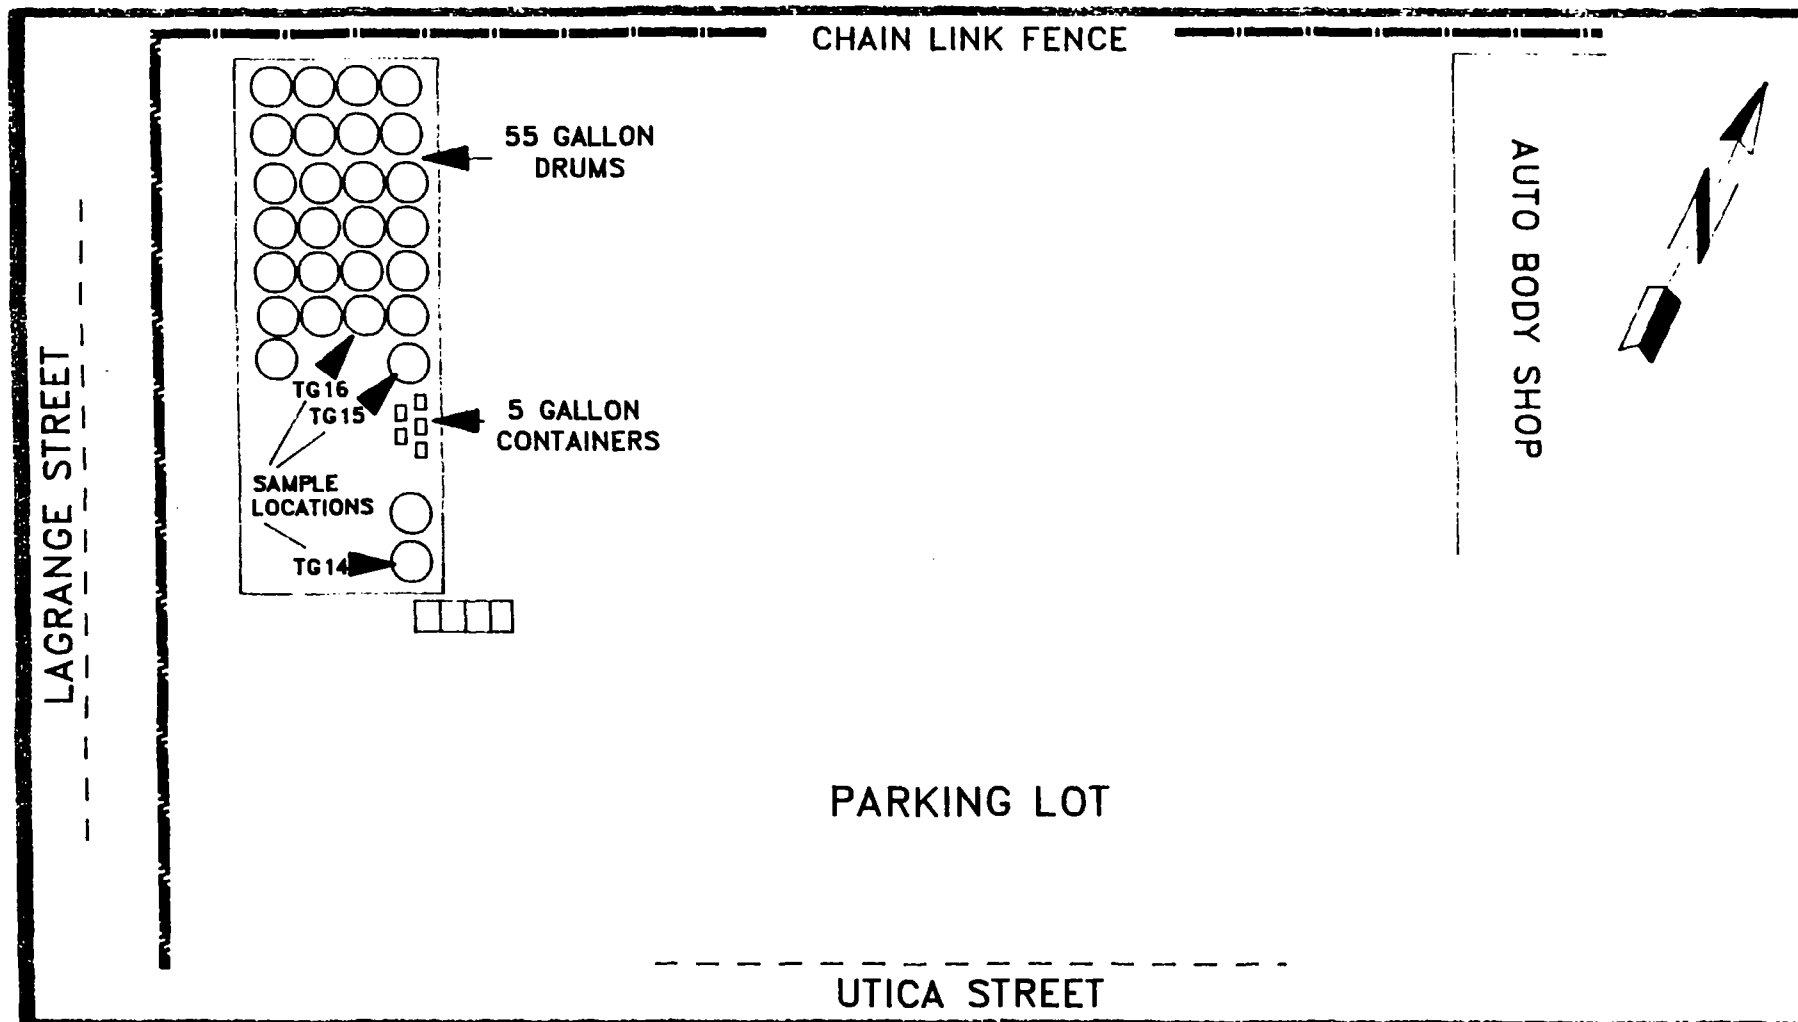
FIGURE 5  
TRAILER SKETCH  
TOLEDO PLATE & GLASS SITE  
TOLEDO, LUCAS COUNTY, OHIO  
NOT DRAWN TO SCALE

The TAT members then entered the trailer on the west side of Utica Street (Figure 5). The trailer, situated inside a fenced yard, was not secured, and not in good condition. Its stairs, tail gate, and support blocks were unstable. Twenty-eight 55-gallon drums and several 5-gallon pails were found in the trailer; no signs of leakage were observed on the trailer bed or on the soil below the trailer. HNu readings reached 5 to 10 units inside the trailer. Readings of 190 units were observed on the HNu while sampling drum TG14.
